Background

Aims

Hardware Setup

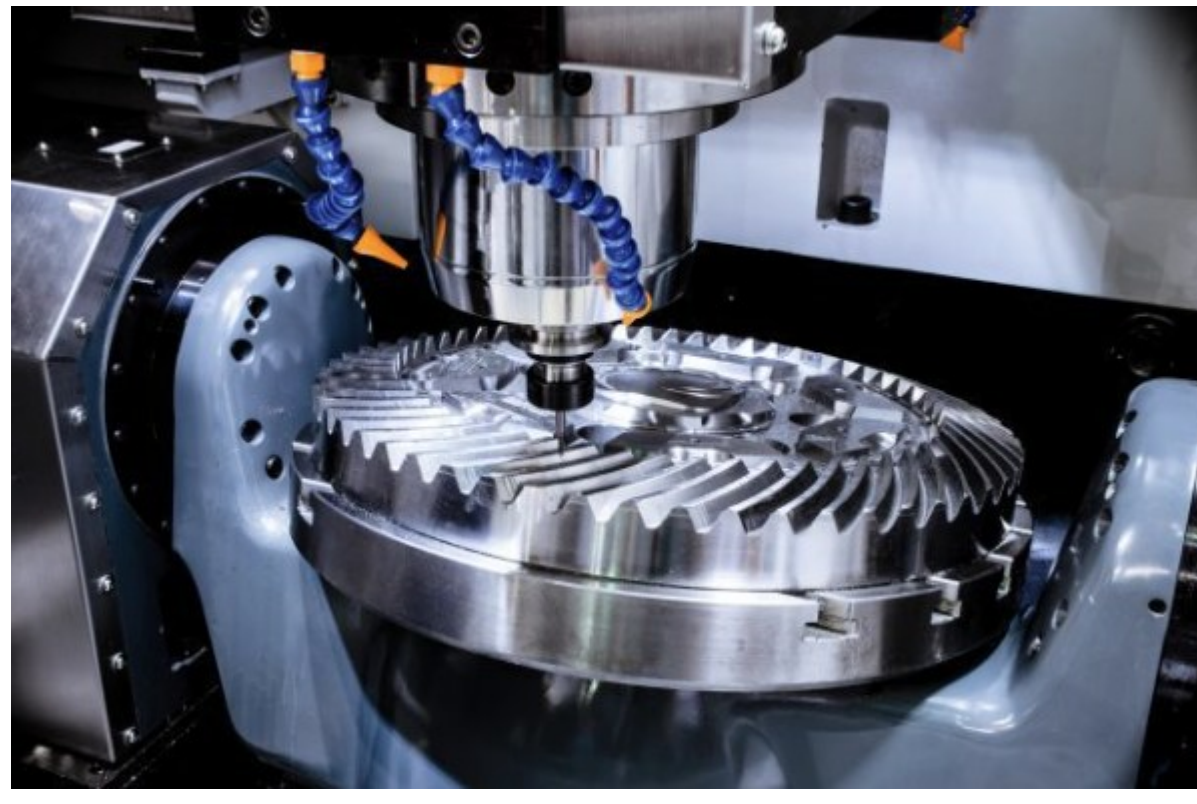
Fig. 1 5 axis Computer Numerical Control machine cutting cogwheel

- CNC machines are computer-controlled tools that cut and shape materials by moving a spindle and cutting tool precisely along programmed paths.
- Unexpected tool wear and breakage causes downtime, scrap and safety risks.
- Tool health monitoring systems use a variety of sensors to evaluate a cutting tools health.

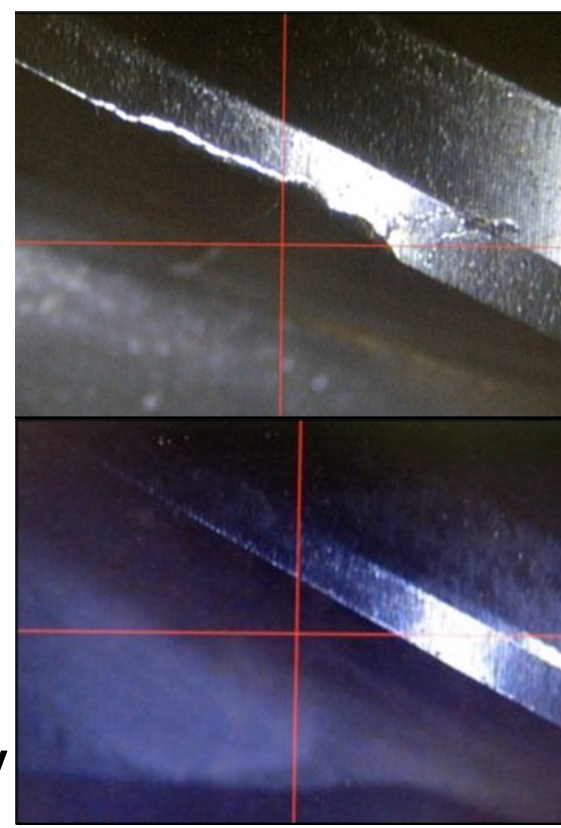
Fig. 2 No tool wear vs. excessive tool wear.

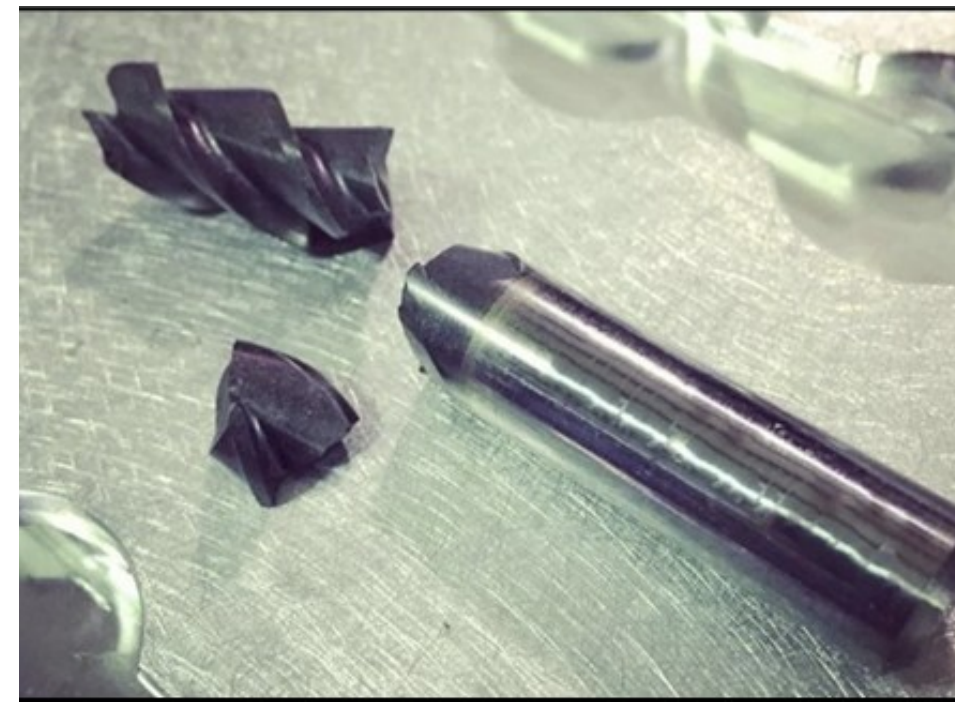
Fig. 3 Fractured end mill cutting tool.

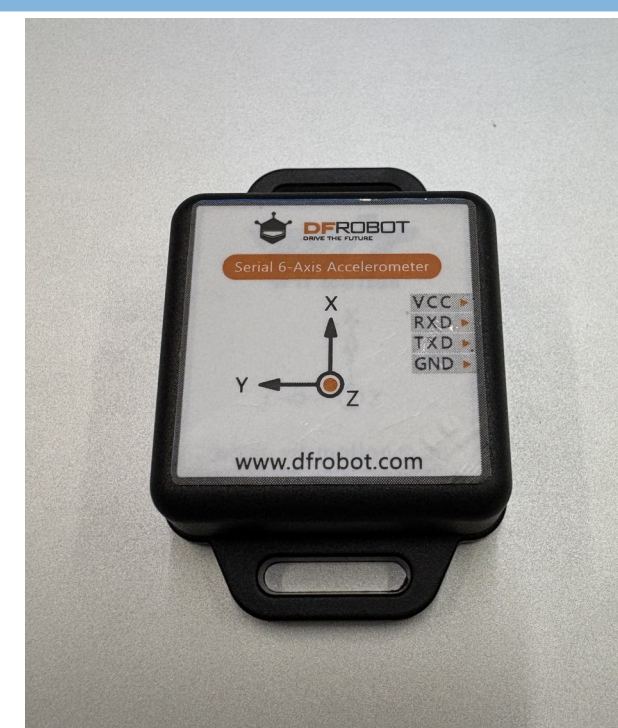
Fig. 4 Inertial Measurement Unit.

Sensor: DFRobot serial 6-axis Inertial Movement Unit, ± 16 g and $\pm 2000^\circ/s$, 0.1 to 200 Hz.

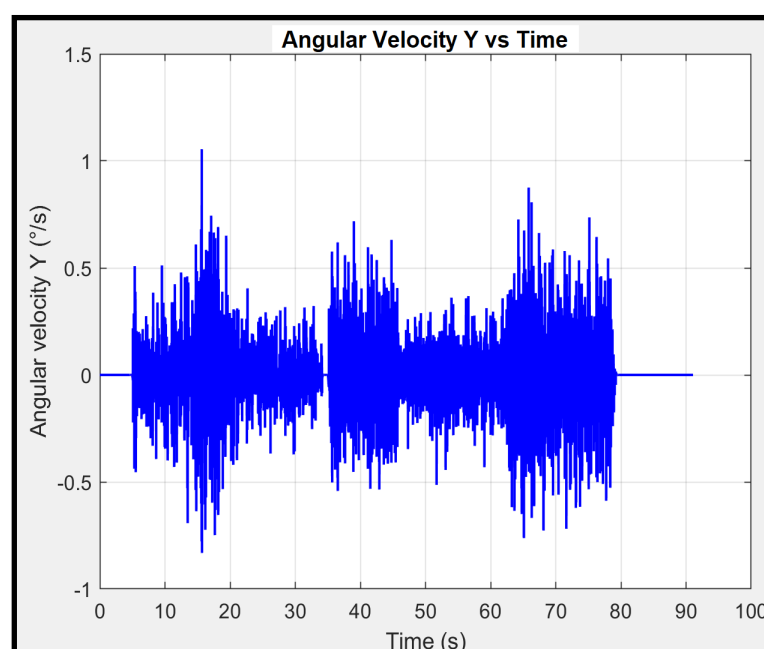
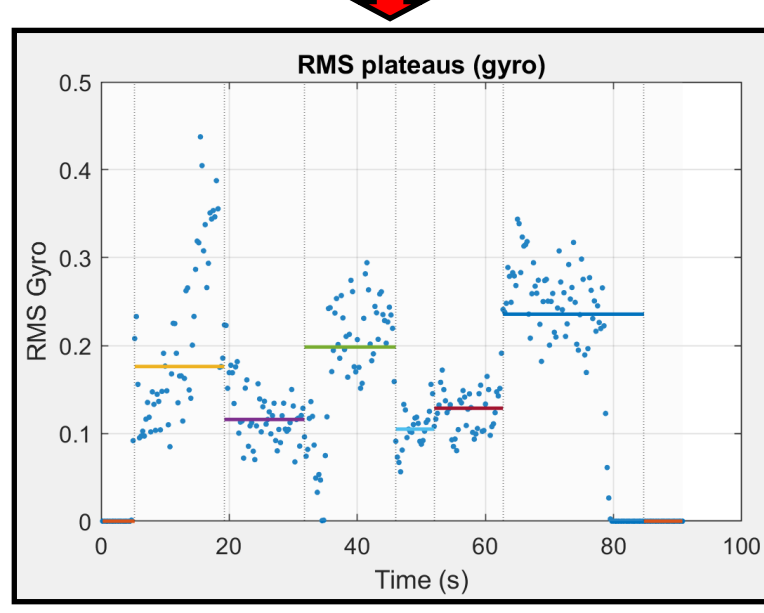
Fig. 5 Aim to signal process data.

Achieving these aims will determine whether a low-cost IMU sensor is a viable method for tool condition monitoring. A pipeline will standardise data capture and preprocessing, apply consistent state labelling, and output reusable, ready-to-train datasets that support threshold-based monitoring now and straightforward model training later.

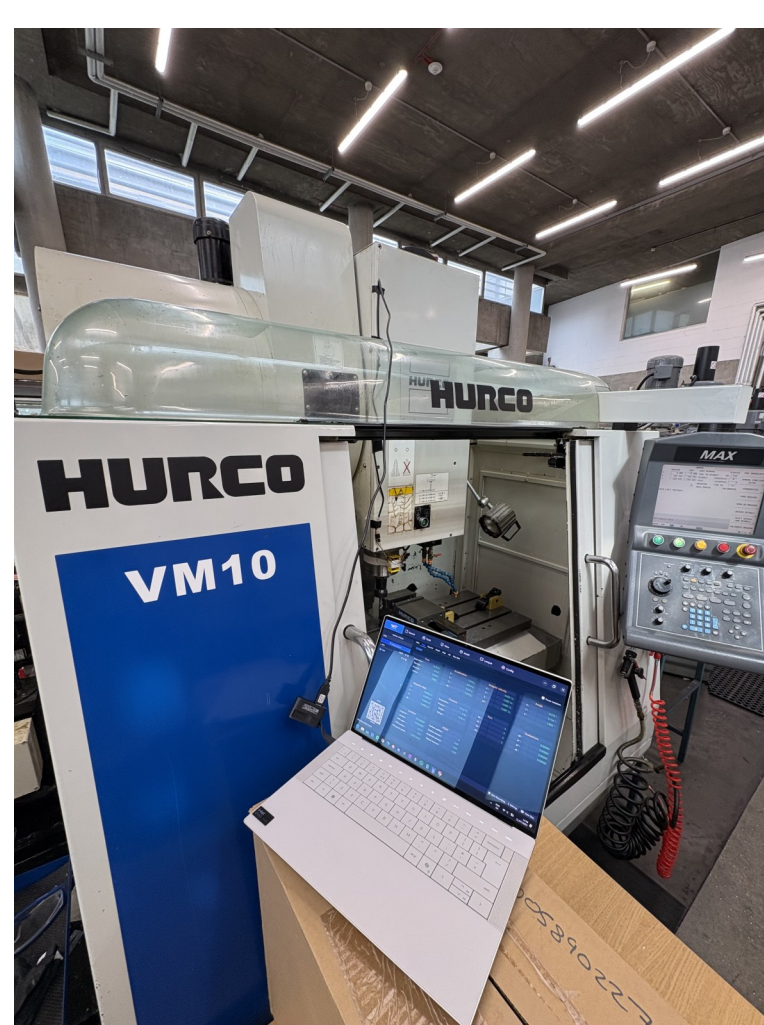
Fig. 6 Hurco VM10 CNC machine used for testing.

Mount: 3D-printed with magnets, attached to Hurco VM10 3 axis CNC machine.

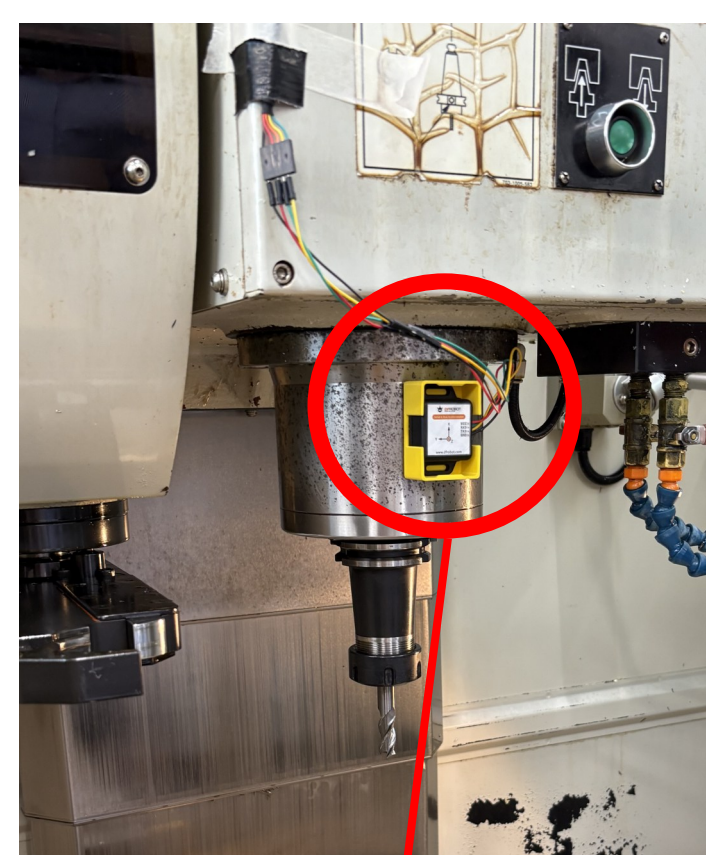
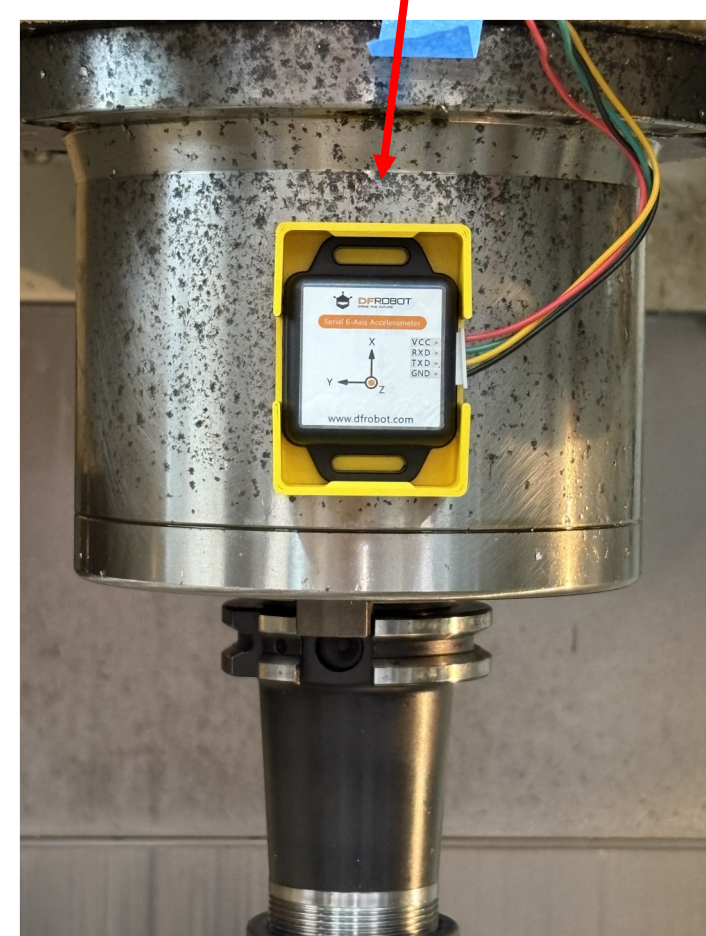
Fig. 7 Position of IMU on spindle

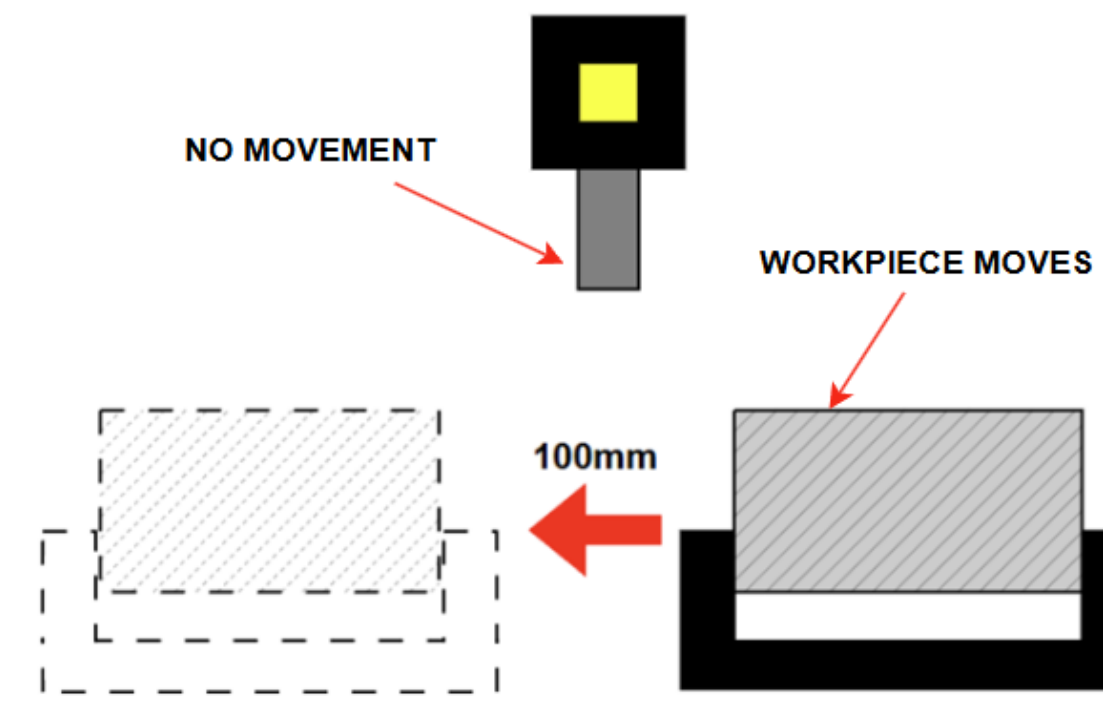
Fig. 10 Workpiece movement test.

Linear table movement was not detectable with this signal and mount position.

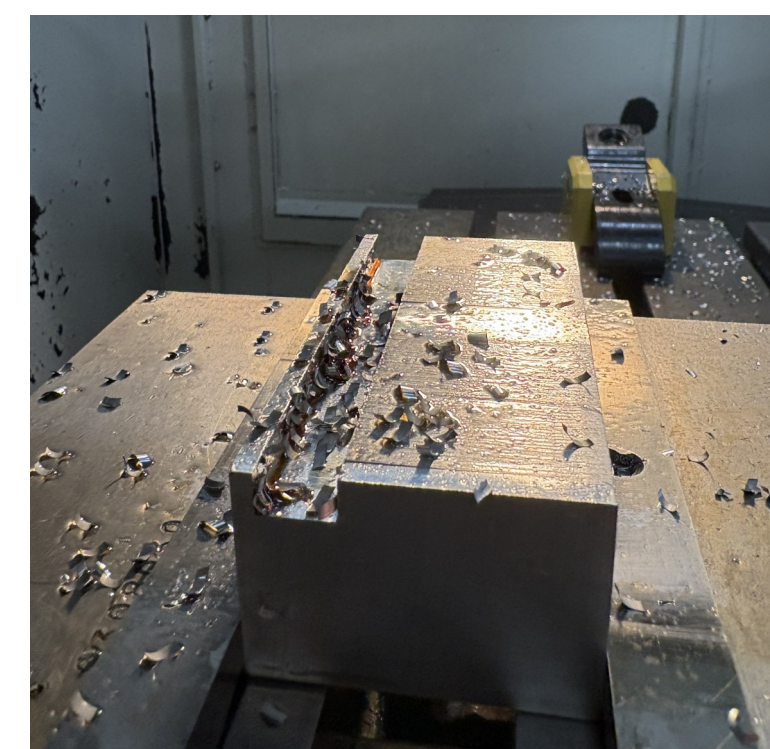
Fig. 12 Aluminium workpiece after 3mm depth cut.

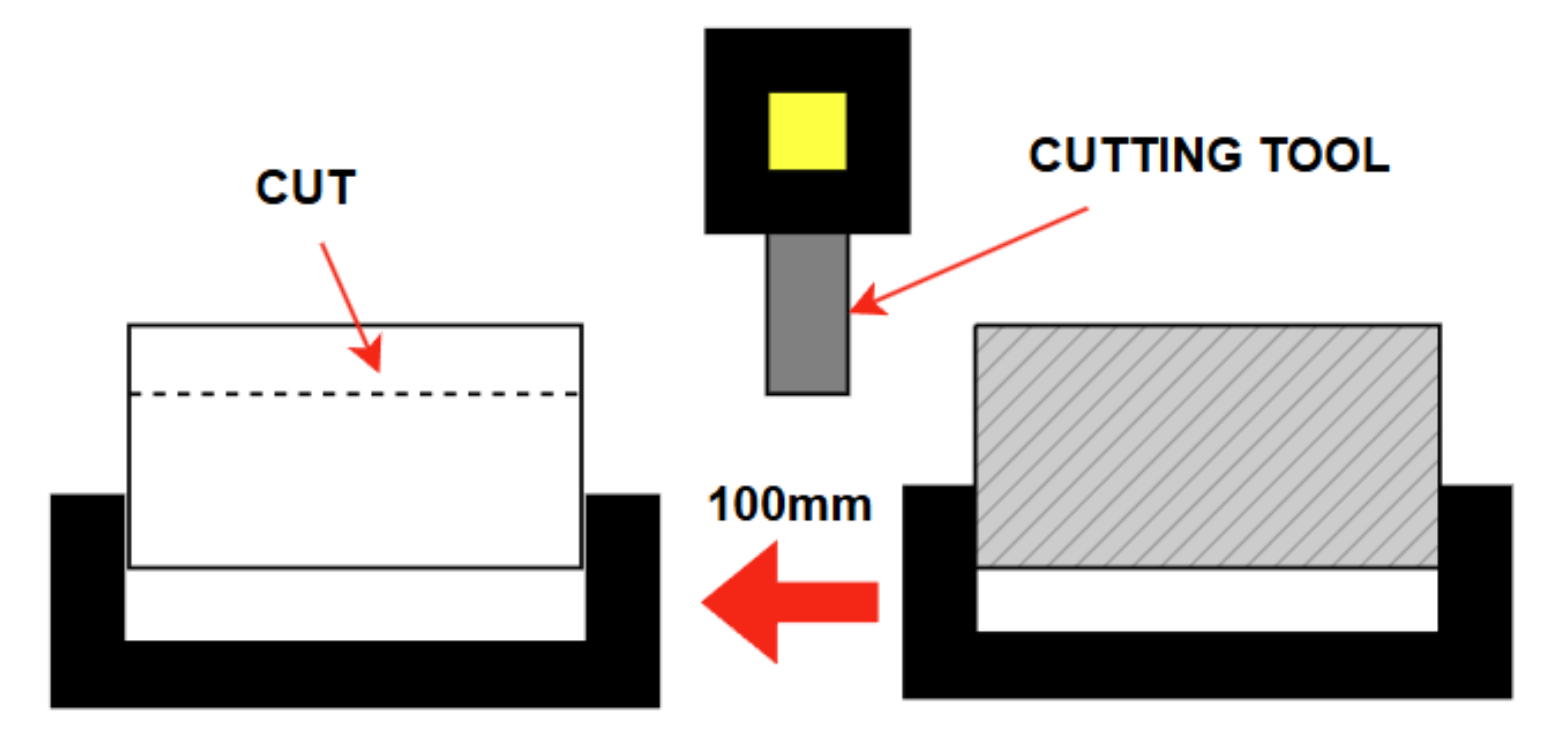
Fig. 13 Cutting the workpiece test.

Angular velocity RMS content approximately separated initial spin up, air cut and metal cut but struggled with further separation.

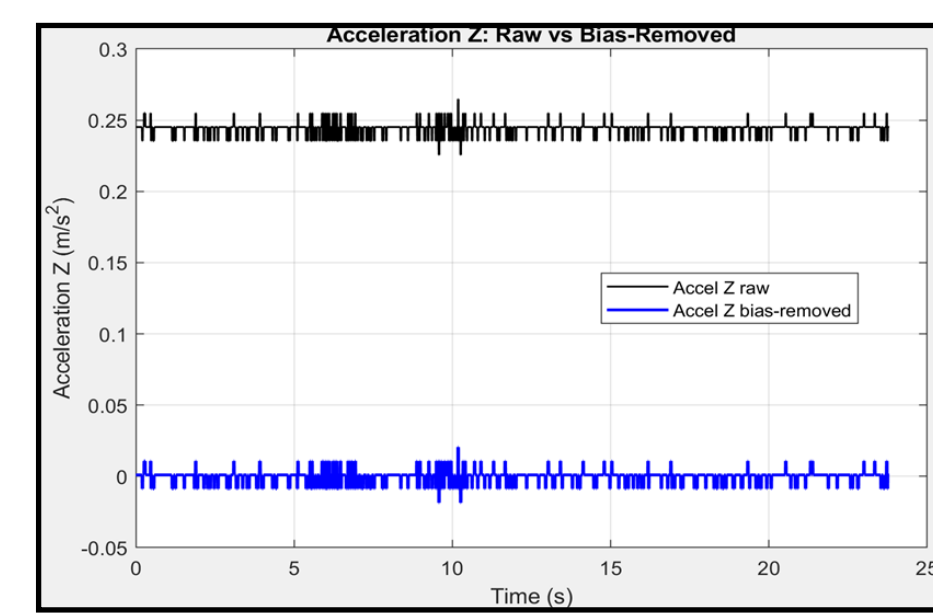
Electric noise produces jitter, this steady bias causes integration drift. Bias removal stabilised the signal.

Fig. 14 Signal with and without bias removal.

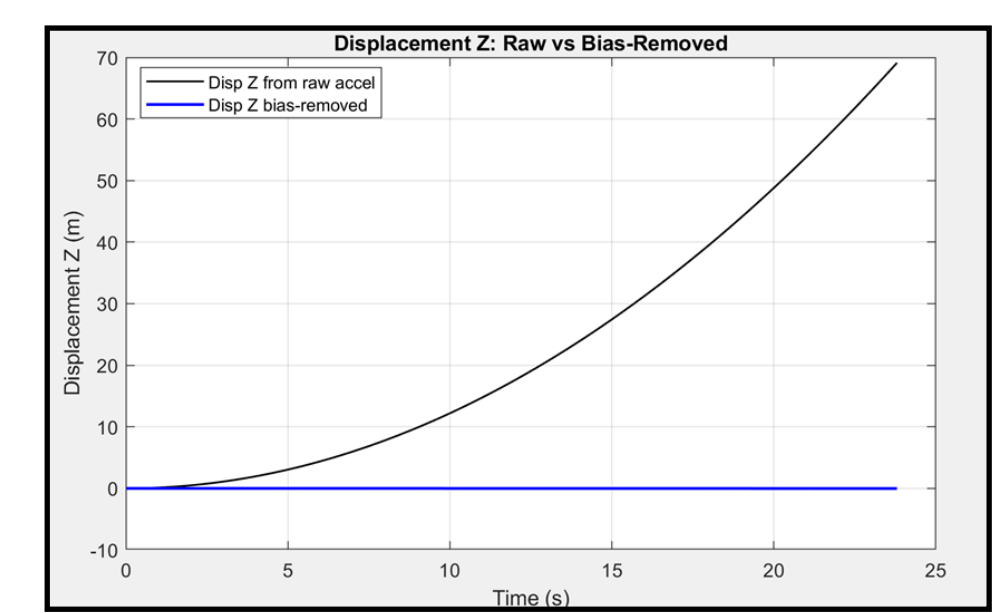
Fig. 15 Integration drift with and without bias removal.

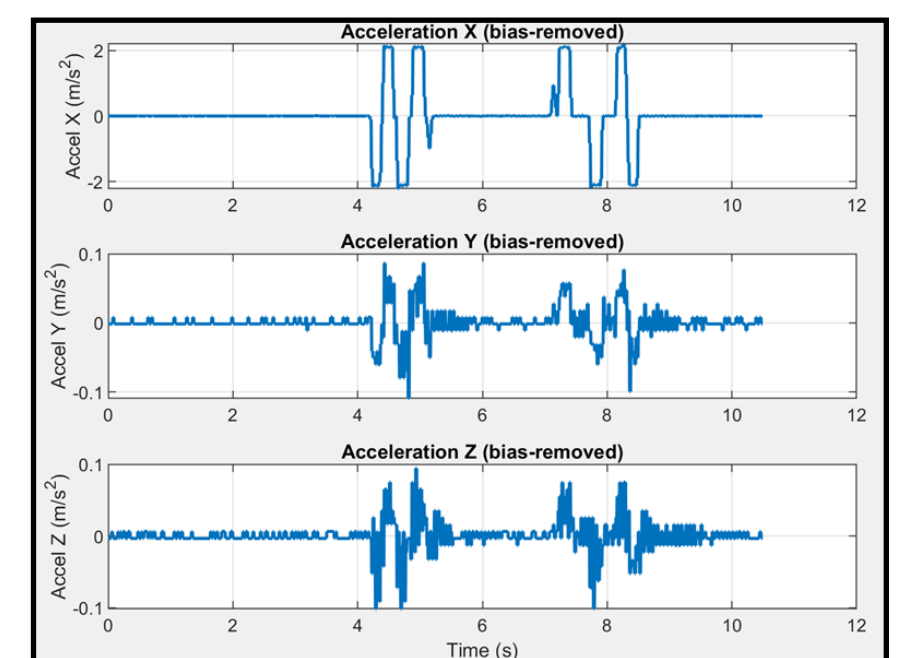
Clear acceleration, deceleration and jerk peaks. Feed 3000 showed higher peaks and approximately half the segment time compared with 1500. Cross-axis leakage confirms the IMU axes were not aligned exactly to machine axes.

Fig. 16 Acceleration cross-axis leakage.

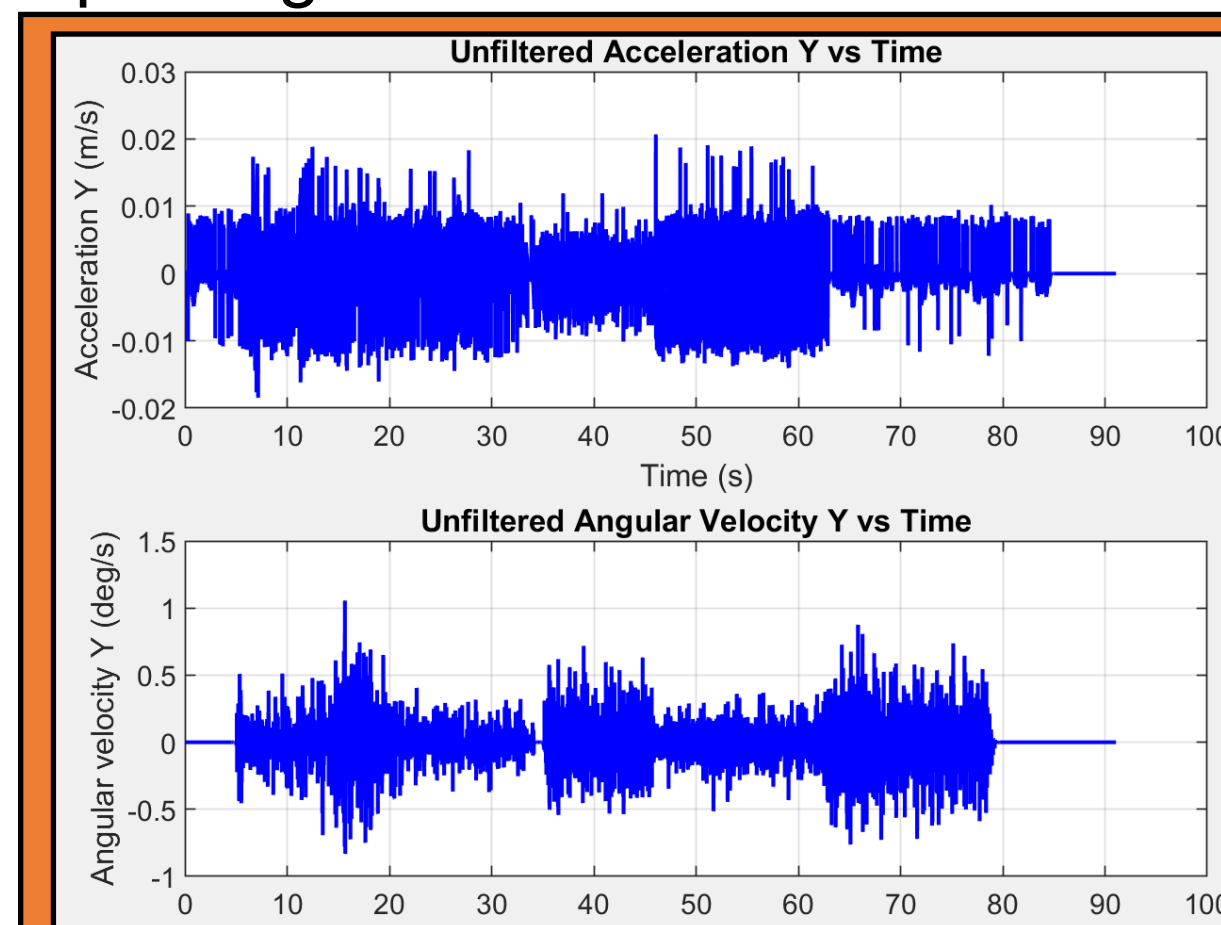
Fig. 17 Unfiltered acceleration and gyro (angular velocity) signal.

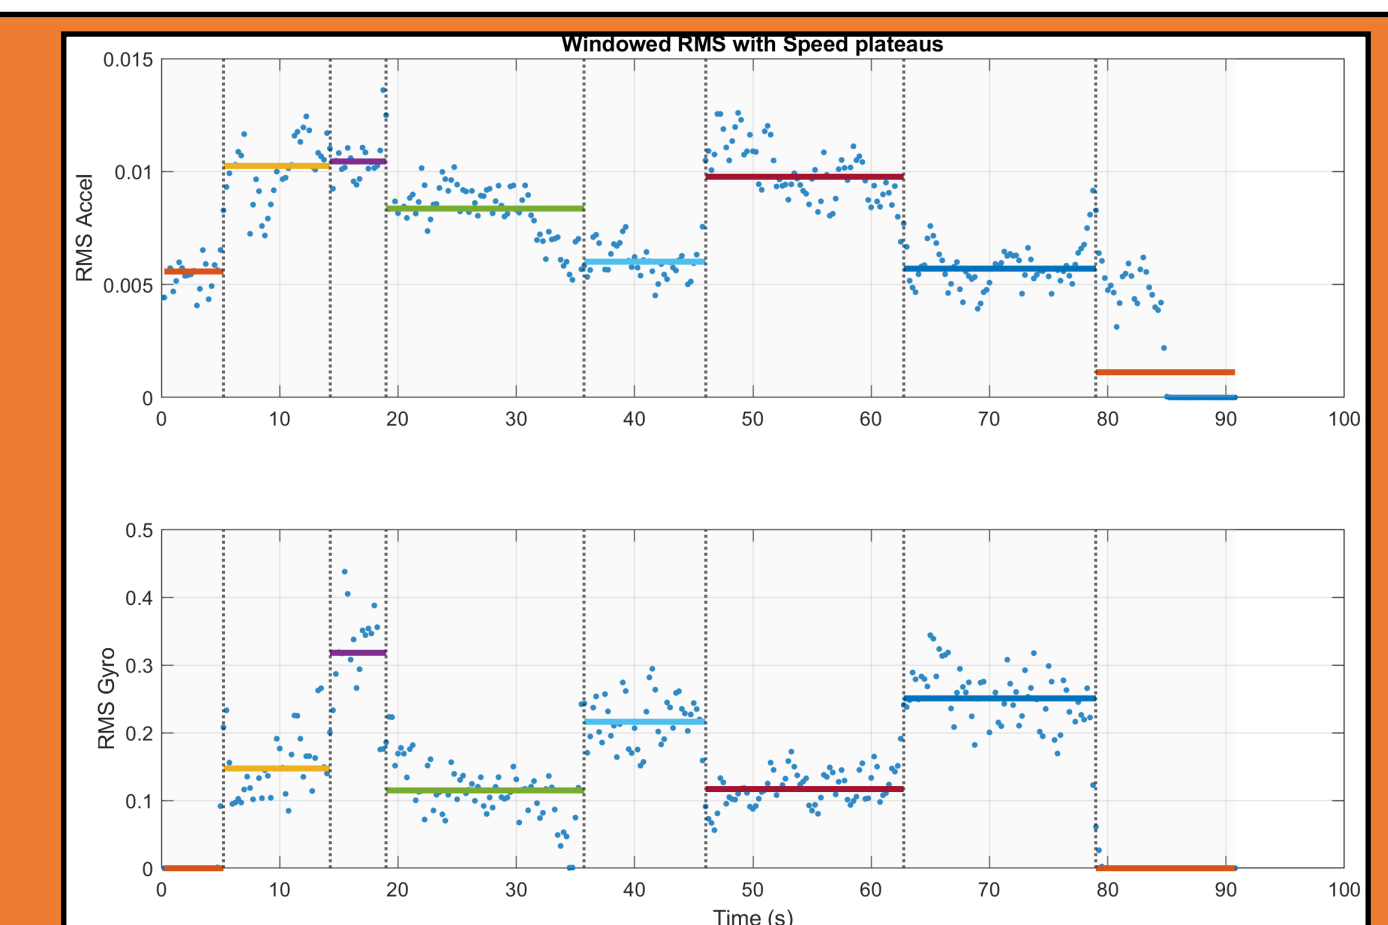
After filtering (3Hz High Pass IIR) and windowing, plateau detection grouped steady rpm segments.

Fig. 18 Filtered acceleration and gyro with plateaus for areas of steady RPM.
